ON-SITE AMBULANCE CRASH INVESTIGATION

CASE NUMBER - IN11024

VEHICLE - 1996 FORD E350 TYPE III AMBULANCE

CRASH DATE - July 2011

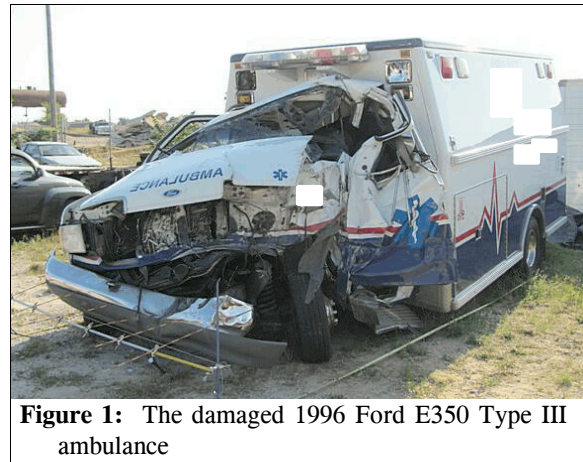
Figure 1: The damaged 1996 Ford E350 Type III ambulance

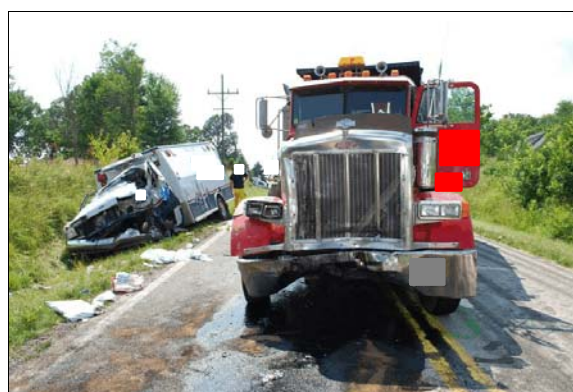
Crash: The Peterbilt entered the ambulance's travel lane where the front plane of the Peterbilt (**Figure 4**) impacted and overrode the front bumper of the ambulance (**Figure 5**, event 1). The impact occurred 2.6 m (8.5 ft) into the ambulance's travel lane. A witness reported to police that the back end of the ambulance pitched up several feet off the pavement at impact. The WinSMASH program calculated a Barrier Equivalent Speed for (BES) the ambulance of 31 km/h (19.3 mph). Based on the damage to the ambulance, the BES appeared low. The ambulance entered the ditch and traveled approximately 5 m (16 ft) where the right plane impacted the back slope of the ditch (event 2). The vehicle traveled an additional 2 m (6.6 ft) and came to final rest in the ditch heading southeast. The Peterbilt rotated counterclockwise approximately 140 degrees for 11 m (36 ft) and came to rest in the middle of the roadway heading southeast.

Figure 4: Police on-scene photo viewed west showing final rest positions of the ambulance and the Peterbilt

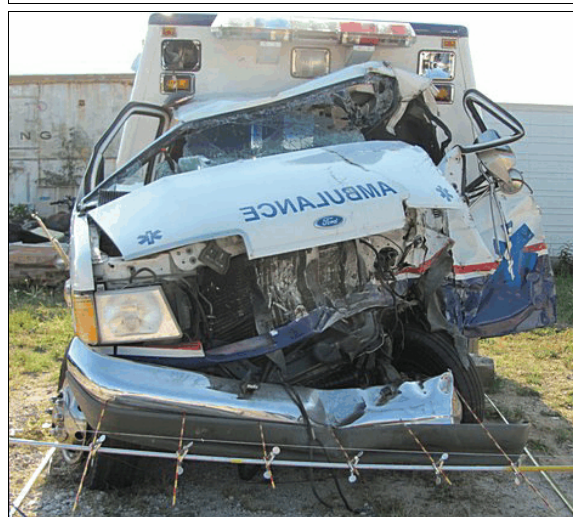
Figure 5: Damage to the front plane of the ambulance from impact with the front plane of the Peterbilt

Exterior Damage Event 1: The ambulance sustained front plane damage during the impact with the Peterbilt (event1). The front bumper, grille, hood, left head lamp/turn signal assembly, left fender, left front wheel, left A-pillar, and left front door were directly damaged. The direct damage on the front plane began at the front left bumper corner and extended 116 cm (45.7 in) along the front plane. The Field L was 145 cm (57.1 in). The crush measurements were taken at the front bumper level and upper radiator frame level since the vehicle was overridden by the front bumper of the Peterbilt. The maximum residual crush occurred at C_1 and was 44 cm (17.3 in) at the bumper level and 87 cm (34.3 in) at the radiator frame level. The crush measurements met the crush averaging protocol and the maximum average crush at C_1 was 66 cm (26 in). The averaged crush values were: $C_1=66$ cm (26 in), $C_2=47$ cm (18.5 in), $C_3=40$ cm (15.7 in), $C_4=24$ cm (9.4 in), $C_5=9$ cm (3.5 in), $C_6=0$ cm. The vehicle's left side wheelbase was reduced 51 cm (20.1 in), while the right side wheelbase was extended 8 cm (3.1 in).

Damage Classification, Event 1: The Collision Deformation Classification (CDC) for the impact with the Peterbilt was 11FYAW6 (340 degrees). The WinSMASH program could not be used to calculate Delta V since an impact with a heavy truck is out of scope for the program. The WinSMASH program was used to calculate a Barrier Equivalent Speed (BES) based on the front crush to the ambulance. The calculated BES was 31 km/h (19.3 mph). The BES value appeared low based on the damage to the vehicle.

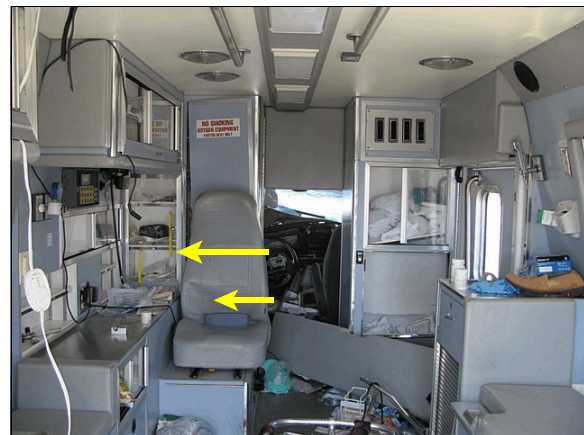
The inspection of the patient compartment revealed that the plexiglass door to the rear-facing supply cabinet (**Figure 6**) at the front left of the patient compartment was fractured and the lower right portion of the seat back of the rear-facing seat was dented. The door to the electrical cabinet located behind the rear-facing seat was also separated from the piano hinge. There were scuff marks on the top and upper left side of the supply cabinet (**Figure 7**) located in the front right of the patient compartment. Scuff marks were also present on the header panel above the right side entry door. These were probably related to occupant contact by the male PM who was seated on the bench seat on the right side of the patient compartment. Following the crash, he was found on top of the patient in the stair well for the right side entry door. The front wall of the patient compartment immediately behind the driver's seat was deformed and fractured from crash forces. The M class oxygen cylinder located under the bench seat was undamaged and remained secured in its cradle by three metal securement straps. There was no damage to the visible oxygen lines. The right side entry door and patient loading doors remained closed and operational. The deformation of the metal entry step for the right side entry door prevented the door from opening

Figure 6: Overview of front of patient compartment; arrows show cracked plexiglass door and dented seat back from probable contact by the PM who was seated on the bench seat on the right side of the patient compartment

to the left opposite the 11 o'clock direction of force. He probably contacted the rear-facing seat and the supply cabinet at the front left of the patient compartment, which fractured the cabinet's plexiglass door. The contact with the supply cabinet caused a comminuted fracture of the left humerus. The contact with the rear-facing seat fractured the right fibula and tibia and sprained the right knee. The PM rebounded and was redirected to the right and contacted the supply cabinet located at the front right of the patient compartment as the right side of the ambulance impacted the embankment. He came to final rest on top of the patient in the step well for the right side entry door. The PM was removed from the patient compartment by emergency responders through the patient loading doors. He was transported by air ambulance to a trauma center where he was hospitalized for eight days.

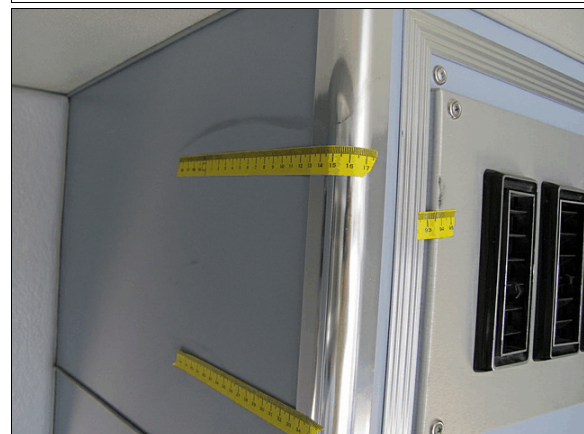
Figure 7: Scuff marks on top of the supply cabinet located in the front right corner of the patient compartment

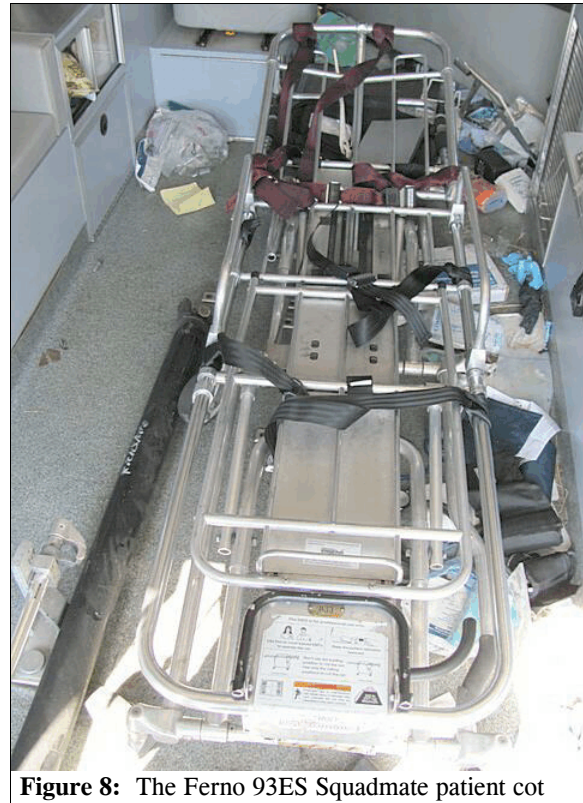
Patient Cot: The cot that was used to transport the patient was a Ferno 93ES Squadmate (**Figure 8**). The identification label was partially worn off the cot and no serial number was located. The cot's mattress was not present at the SCI inspection. The cot was an aluminum H-frame design with swing-down side rails and was adjustable to four height positions. The backrest had eight adjustments that allowed for a range of backrest angles from 0-75 degrees. The inner height adjustment tube was completely fractured at the 6th detent from the bottom (**Figure 9**). The approximate backrest adjustment angle was 47 degrees. The inner adjustment tube was 18 mm (0.7 in) in diameter (**Figure 10**) and the wall thickness of the tube was 3 mm (0.1 in). The outer tube was 33 mm (1.3 in) in diameter and the wall thickness of the tube was 3 mm (0.1 in). The cot was equipped with shoulder/upper torso restraints, lower torso restraints, and leg restraint, all of which were tied to the frame of the cot. The upper and lower torso restraints were buckled and each belt webbing had been cut.

The cot was reported by the operations director to have been secured by the antler bracket and rail clamp. The antler bracket secures the head of the cot by restraining the undercarriage using the wheel frames as anchor points. The rail clamp secured the frame of the cot. The cot was displaced out of its anchors during the crash and came to final rest against the front of the bench seat. The rail clamp was not damaged. The antler clamp was not present. It was reported by the operations director to have been removed during the extrication of the patient.

Figure 8: The Ferno 93ES Squadmate patient cot

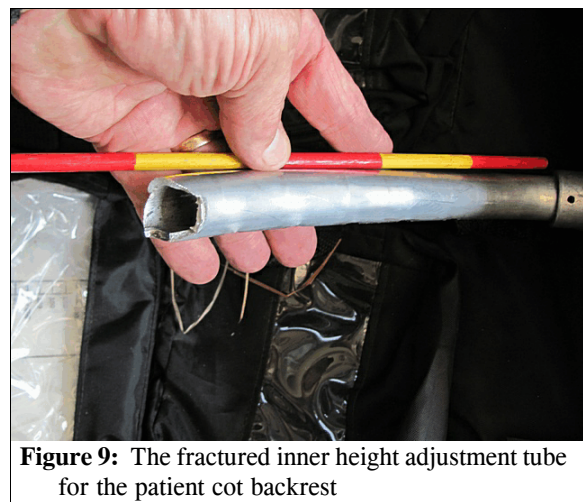
Figure 9: The fractured inner height adjustment tube for the patient cot backrest

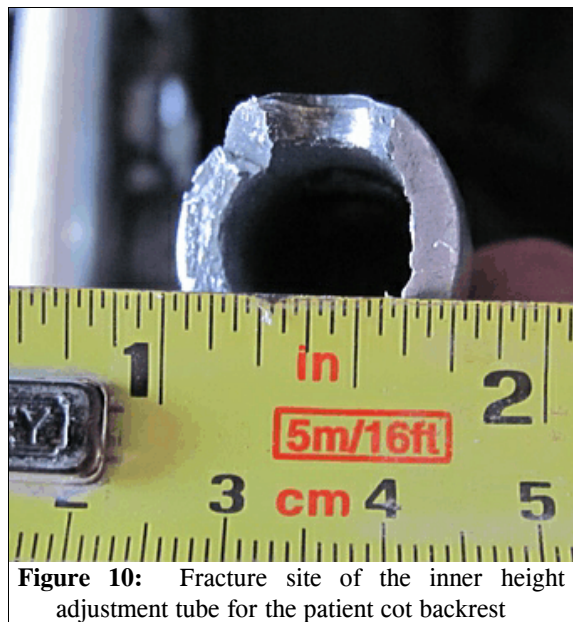
Figure 10: Fracture site of the inner height adjustment tube for the patient cot backrest
